Service Bulletin - Dodge Ball Main board ball gate update.

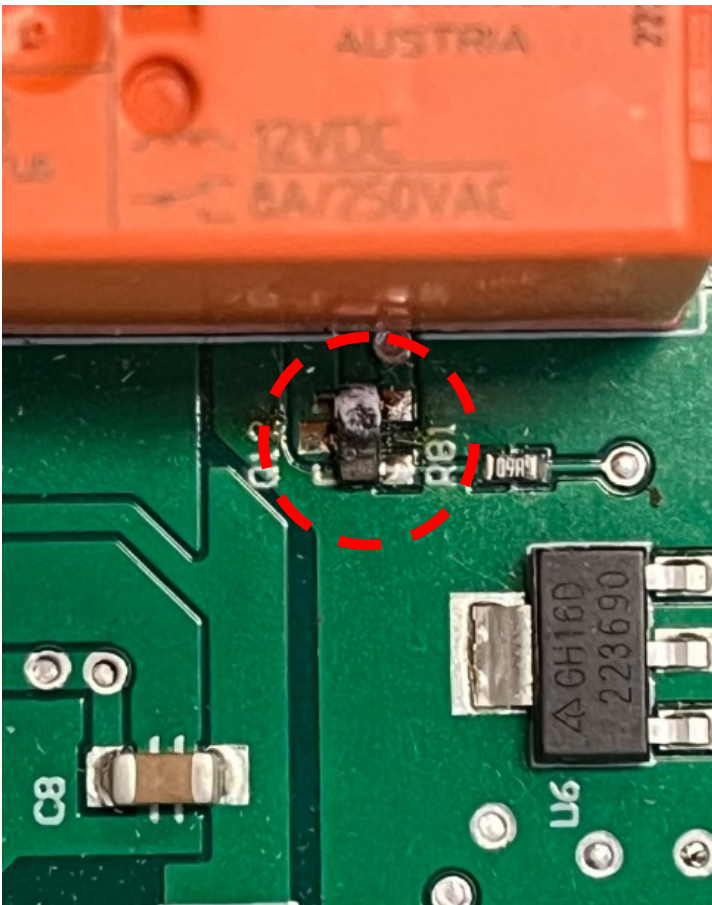
It has come to our attention that the ball gate control transistor can fail causing the ball gate to become inoperative. This transistor is always turned on and is unnecessary.

Failed component at Q12. This controls the ball gate.

Removal of this component and jumping the output with a 0 ohm resistor is recommended.

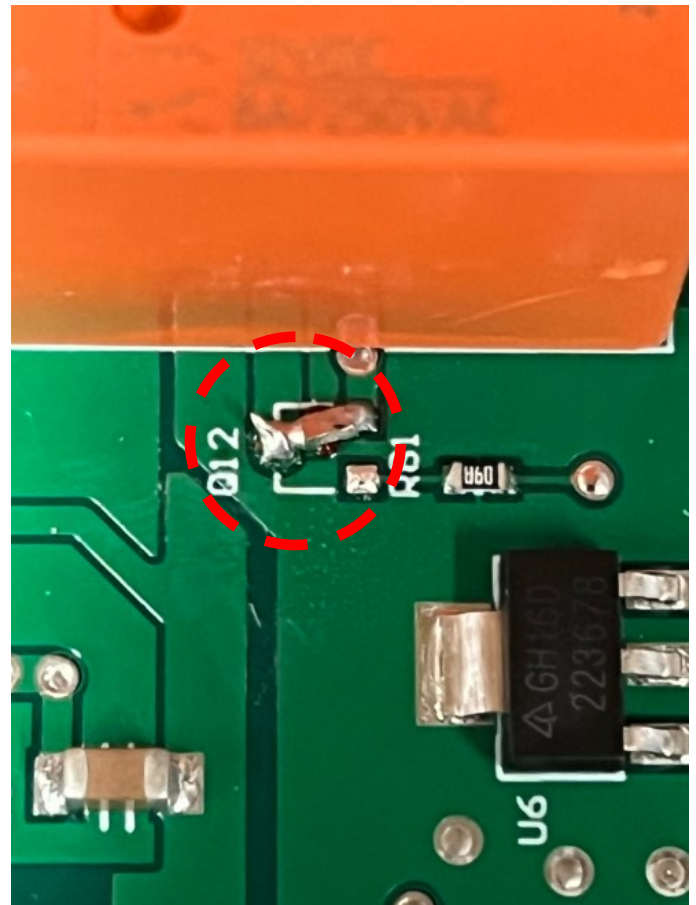
0 ohm resistor installed in place of Q12 transistor.

We have found that this component will fail but once removed, the circuit becomes more reliable.
