Super Chexx Pro Ramp Defect

It has come to our attention that some games manufactured after April, 2025 might contain defective puck ramps (SC1013). If your game is experiencing an issue where the puck does not travel down the puck chute all the way to the ejector, first make sure the path is cleaned from debris. This can be accomplished by pushing the players to the center. Remove the small Phillips screw holding the goaling to the table. Lift up on the goal to remove the player. Now you can peel back the ice surface enough to clean the puck ramp. See steps 1-5 below.

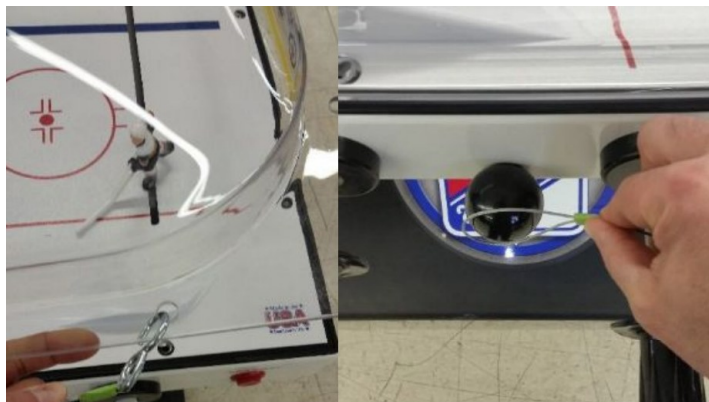
Step 2: Lift the dome and insert the “S” hook end of the metal wire included with your game to one of the bolt holes on the dome. The looped end of the metal wire goes around any handle. This will keep the dome opened.

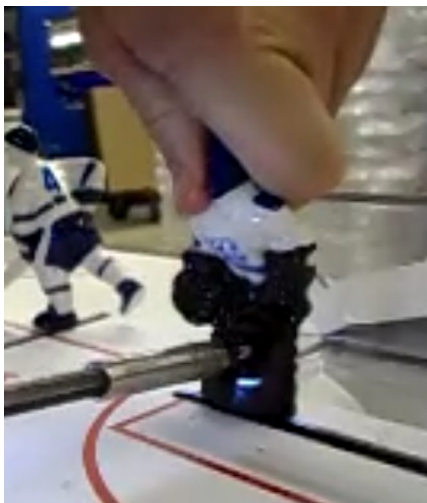
Step 3:

Remove the Phillips screw using a small #1 Phillips screw driver at the front of the goalie player.
