Step 1: Remove Panel Top

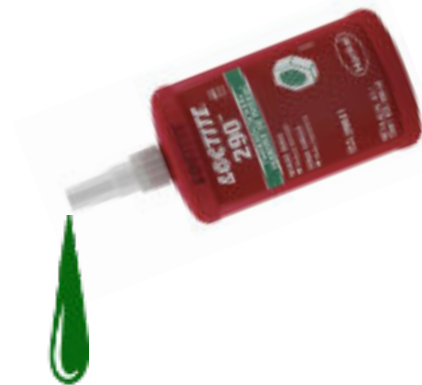
Step 2: Look at the three bolts the hold the hit pad to the cabinet. They are inserted from the bottom. If the bolts are level as in the picture on the right, you can drip Loctite 290 (green wicking type) into the holes of all three bolts. Let stand for 30 minutes. Reassembly the control panel back onto the cabinet.

If not, or they are missing proceed to the next step.

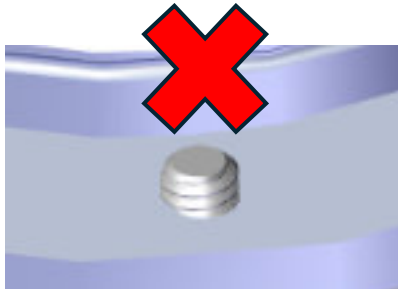
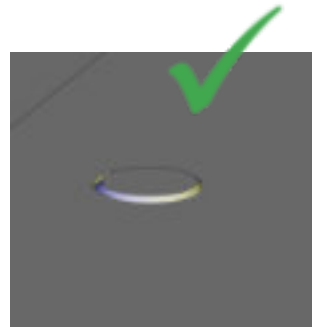
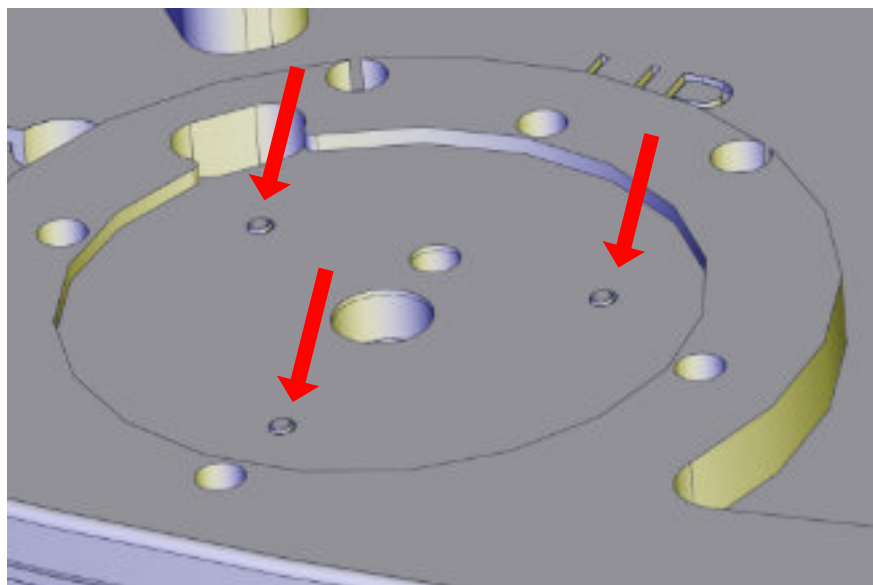
Step 3: Open the coin door and look up to see the three AA6601 bolts that hold the piezo assembly to the cabinet. If missing, install AA6601 1/4-20 1 7/8 bolt and washer AA6212 until the tip is leveled to the other side. If existing bolts are coming out, make sure to tighten until the top of the bolt is even to the surface as shown below. Now follow the previous step and use loctite to secure the bolts.
